## RIVER MILE 10.9 REMOVAL ACTION CAPPING OPERATIONS WEEKLY STATUS REPORT

## Summary of capping operations through week ending April 6, 2014

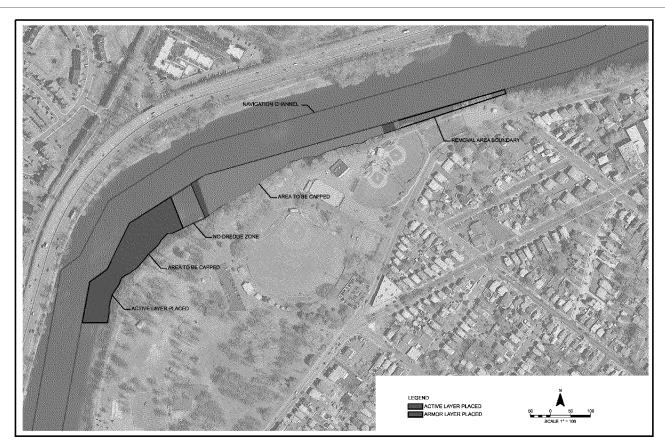
## Capping Progress to Date Shown in Blue

High river flows from the storms that occurred March 29-30, allowed the placement of only one panel of fabric and armoring stone during the week. As of April 6, an estimated 41% of the dredged and capped area has been protected with this armoring layer. Current projections have all work being completed in early to mid-May, 2014. The attached figure shows the section of RM 10.9 where the fabric and stone has been placed to date.
